# **Navajo Abandoned Uranium Mine**

## **Site Screen Report**

### **Black Point-Murphy Group AUM Site**

**January 2011**

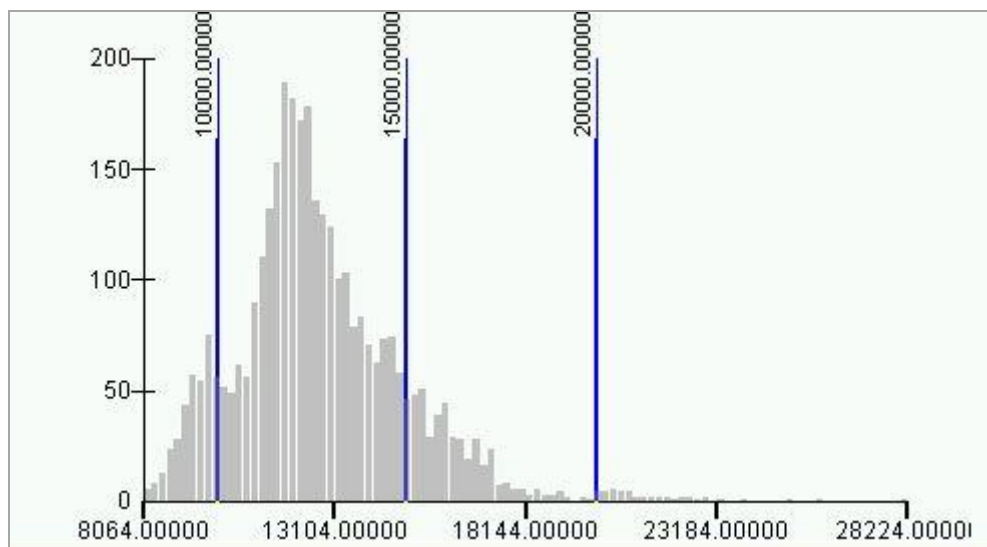
The following chart and statistics were generated by ESRI ArcGIS 9.3.1, and show the general distribution of the site gamma radiation measurements. The horizontal X axis represents the gamma radiation reading levels in cpm (lowest levels to the left). The vertical Y axis represents the frequency of each gamma radiation level.

Count:	3370
Minimum:	8064.00000
Maximum:	28224.00000
Sum:	42889246.00000
Mean:	12726.77923
Median:	12383.00000
Standard Deviation:	2244.39889

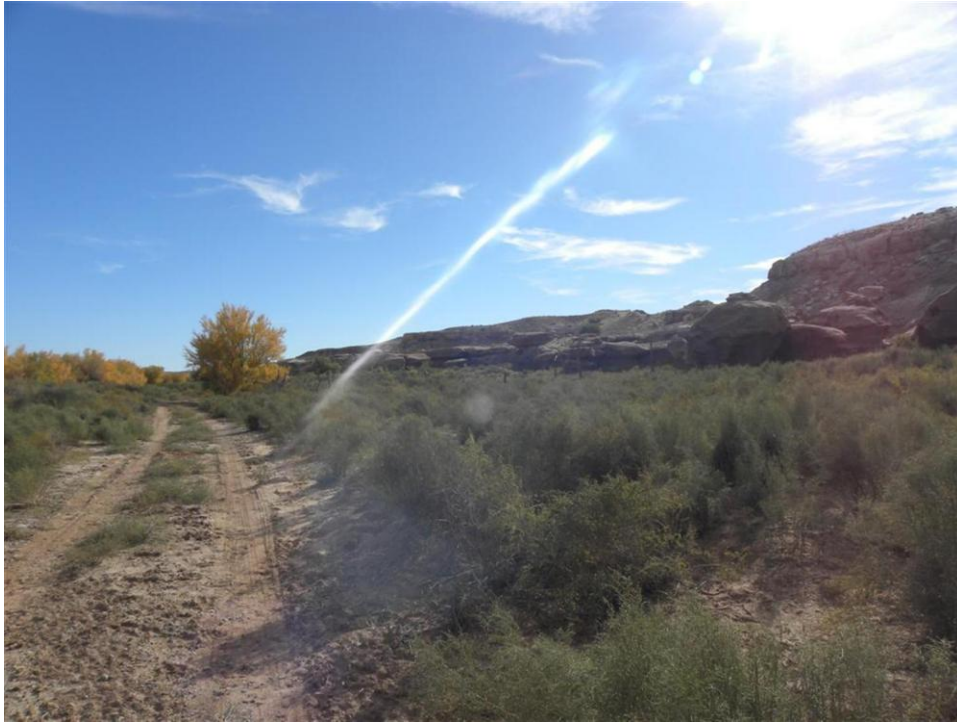
Photo 1. Black Point-Murphy Group mine site

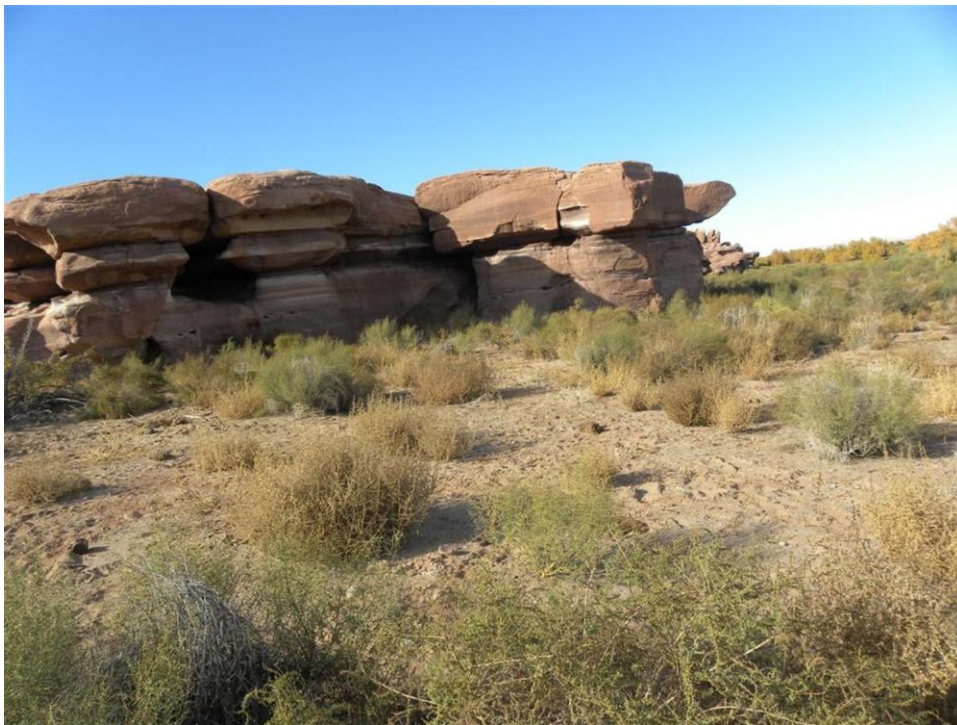
Photo 2. Black Point-Murphy Group mine site

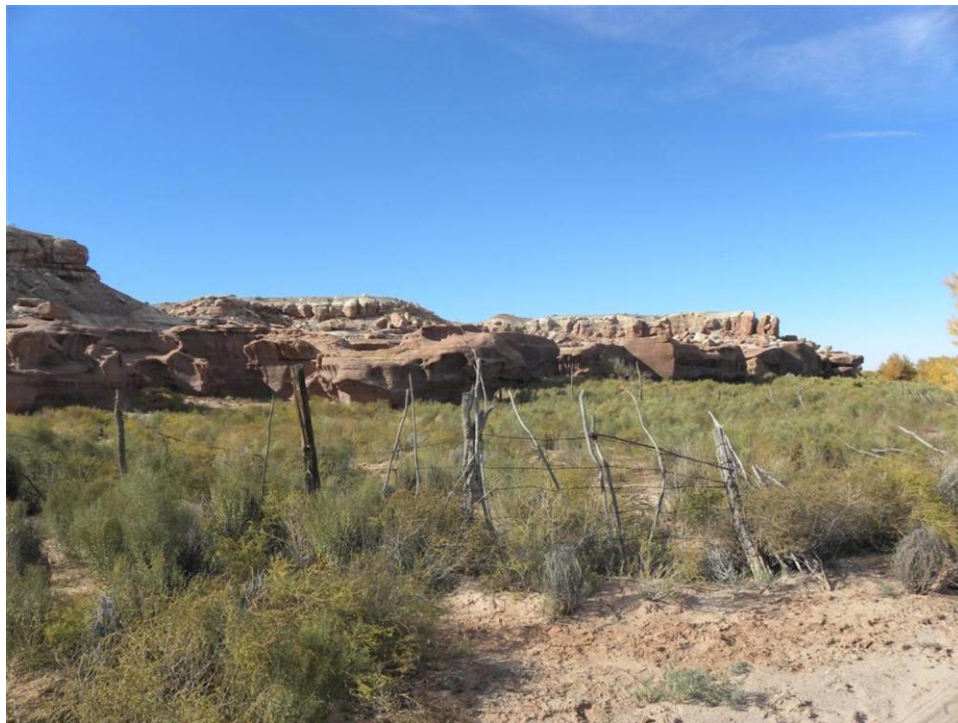
Fenced in area in NW portion of site

Unknown (there is a fenced in area in the NW portion of the site)

Photo 3. Black Point-Murphy Group mine site, fenced in area

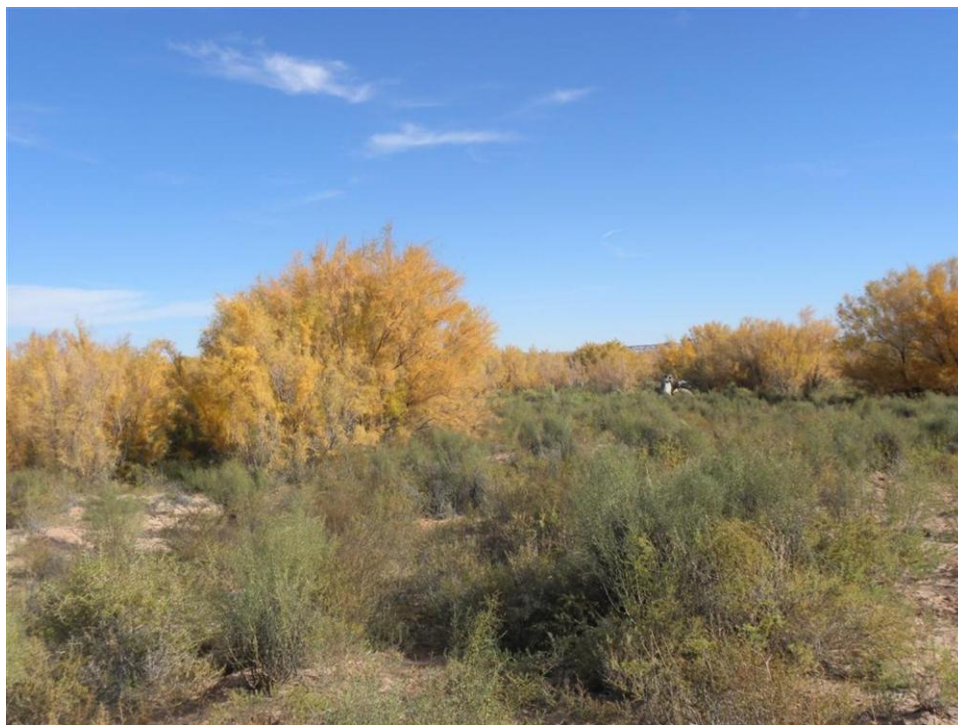
Little Colorado River Basin adjacent to the E of the site, possible wetlands

Photo 4. Black Point-Murphy Group mine site, alongside Little Colorado River Basin

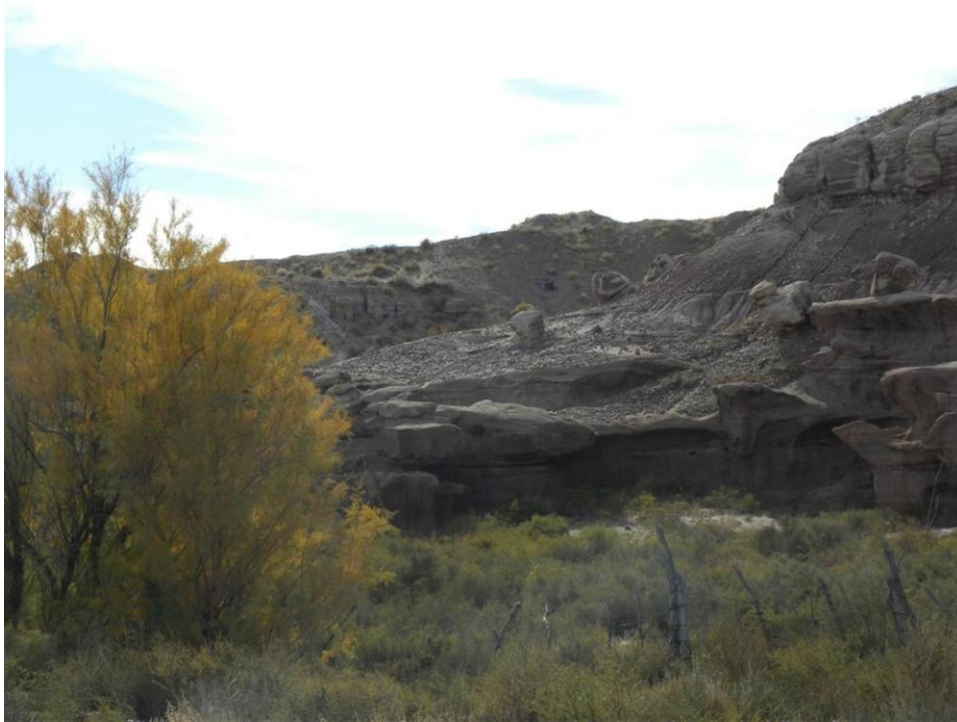
Photo 5. Black Point-Murphy Group mine site, alongside Little Colorado River Basin

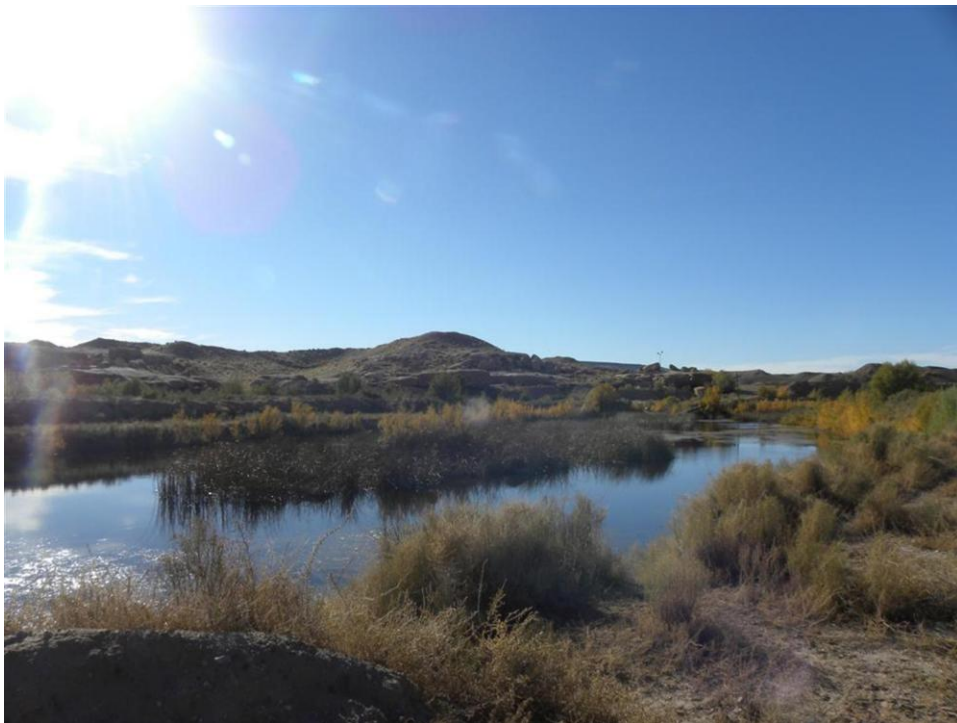
**0 to 0.25 miles:** Pond associated with gravel mining pit approximately 0.15 mi N of the site, all levels background; Little Colorado River Basin adjacent to the E of the site

Photo 6. Black Point-Murphy Group, pond associated with gravel mine 0.15 mi north of site

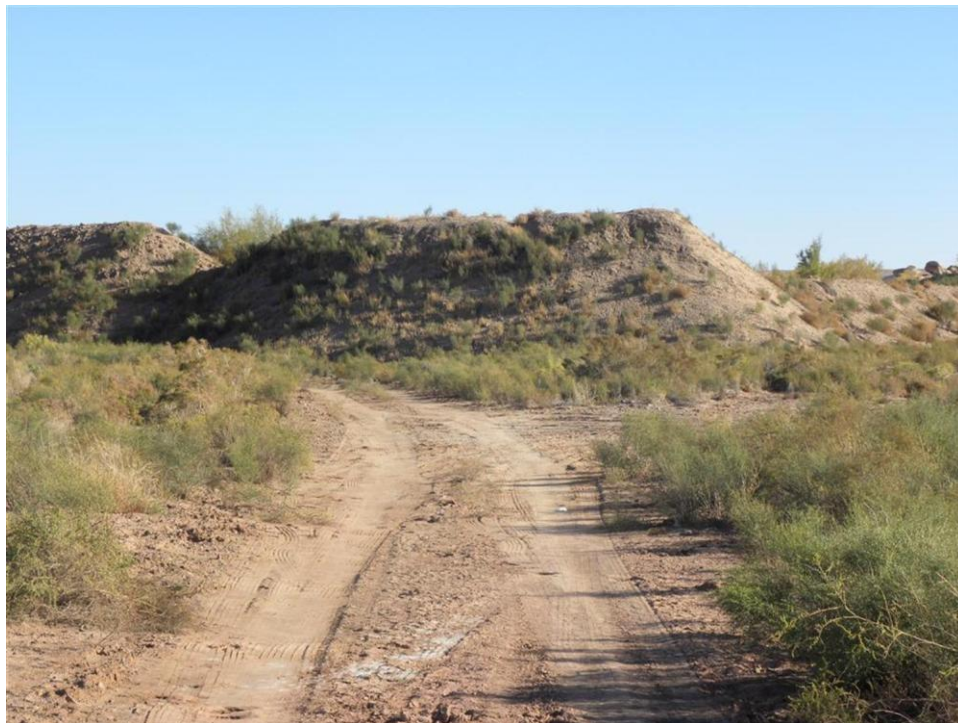
Background levels near gravel mine and pond, road 0.25 mi N of gravel mine had a small section up to 50,000 cpm

Photo 7. Black Point-Murphy Group, road with elevated gamma readings, 0.4 mi north of site

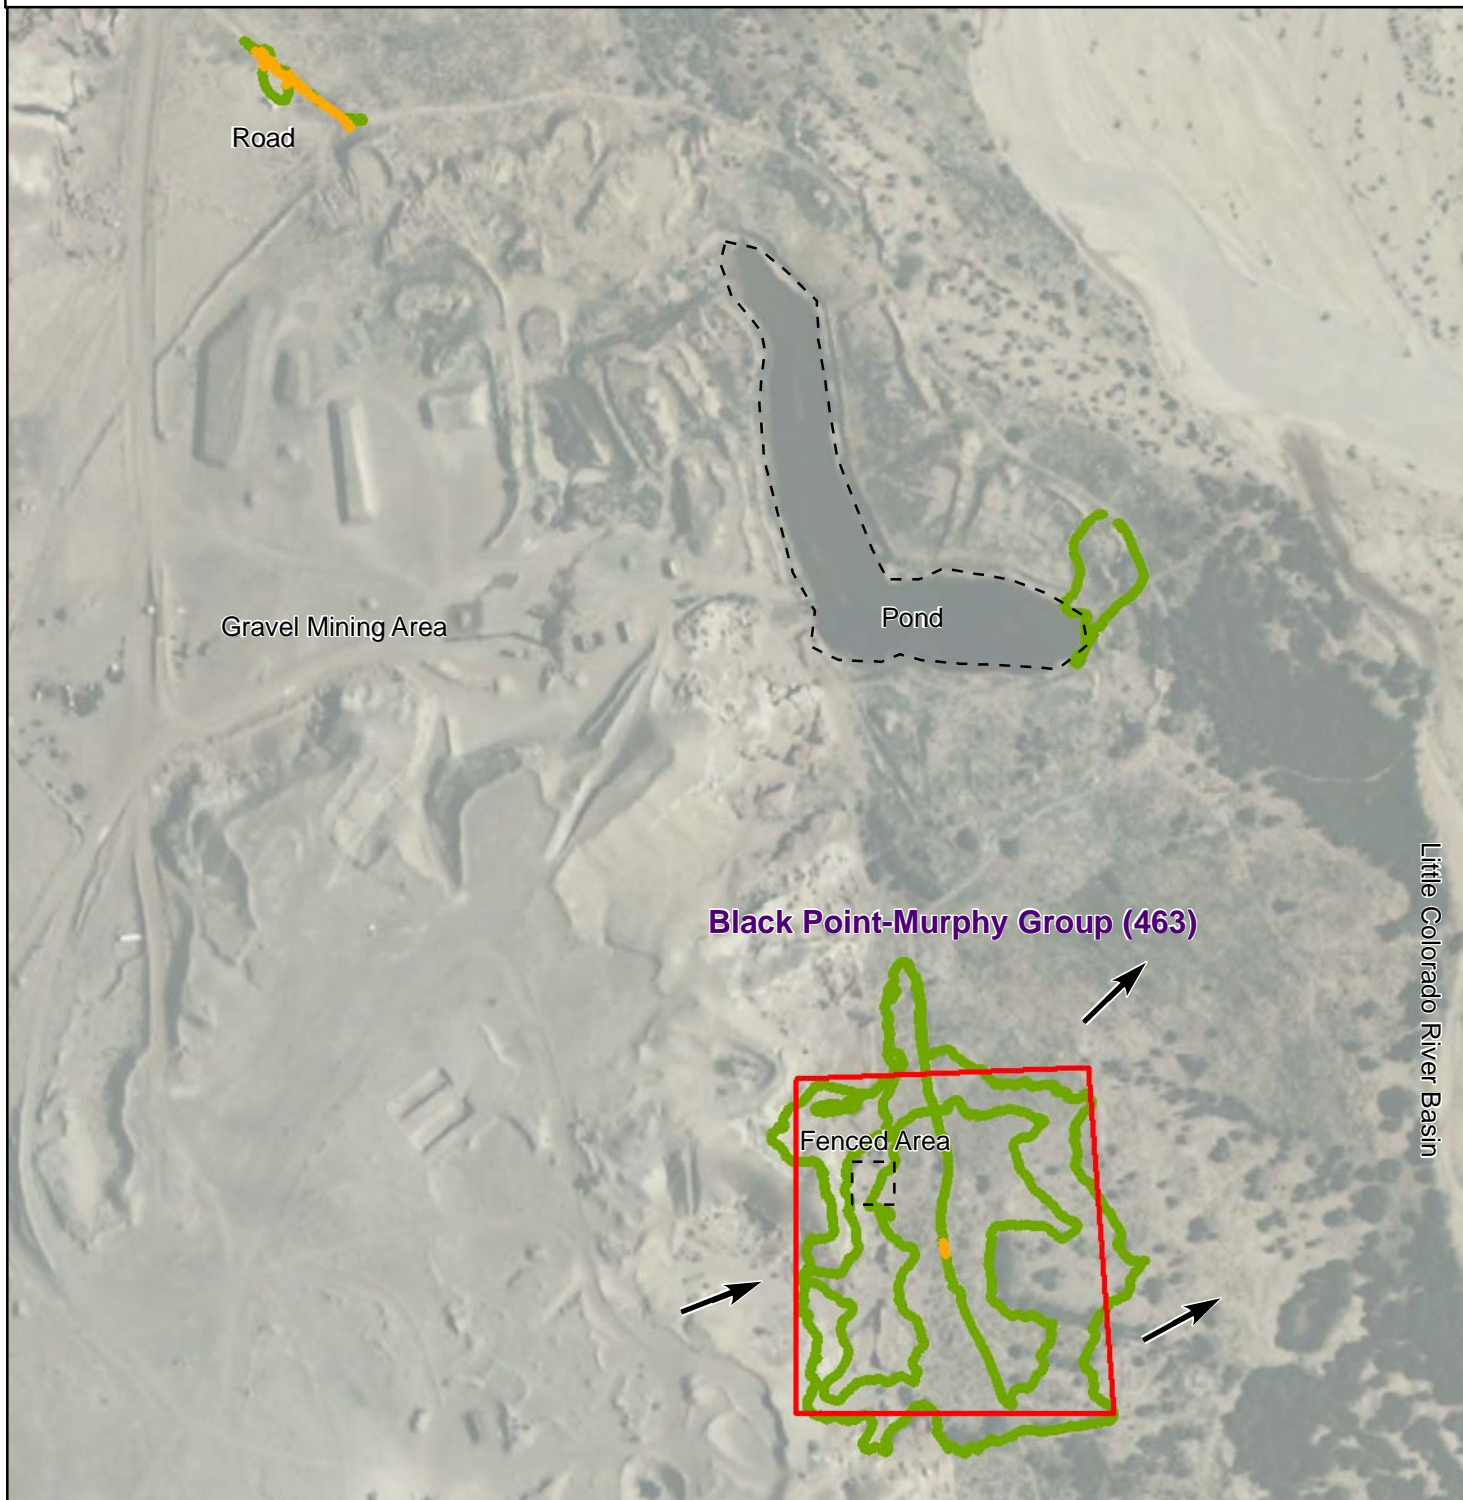
**Figure 1 - Gamma Radiation Measurements, Above Two Times Background  
Black Point-Murphy Group (463)  
Coconino County, Arizona**

A total of 3,370 gamma radiation measurements were collected from the mine site, ranging from 8,064 cpm to 28,224 cpm. The measurements collected at the site and pond 0.15 mi north of the site were found at background levels, but measurements collected from an isolated hot spot along the road 0.4 miles north of the site were found at a maximum level of 50,000 cpm. The measurements are represented in Figures 1 and 2.

Gamma survey conducted 11/2010  
Measured as counts per minute (cpm)

Average background 11,605 cpm

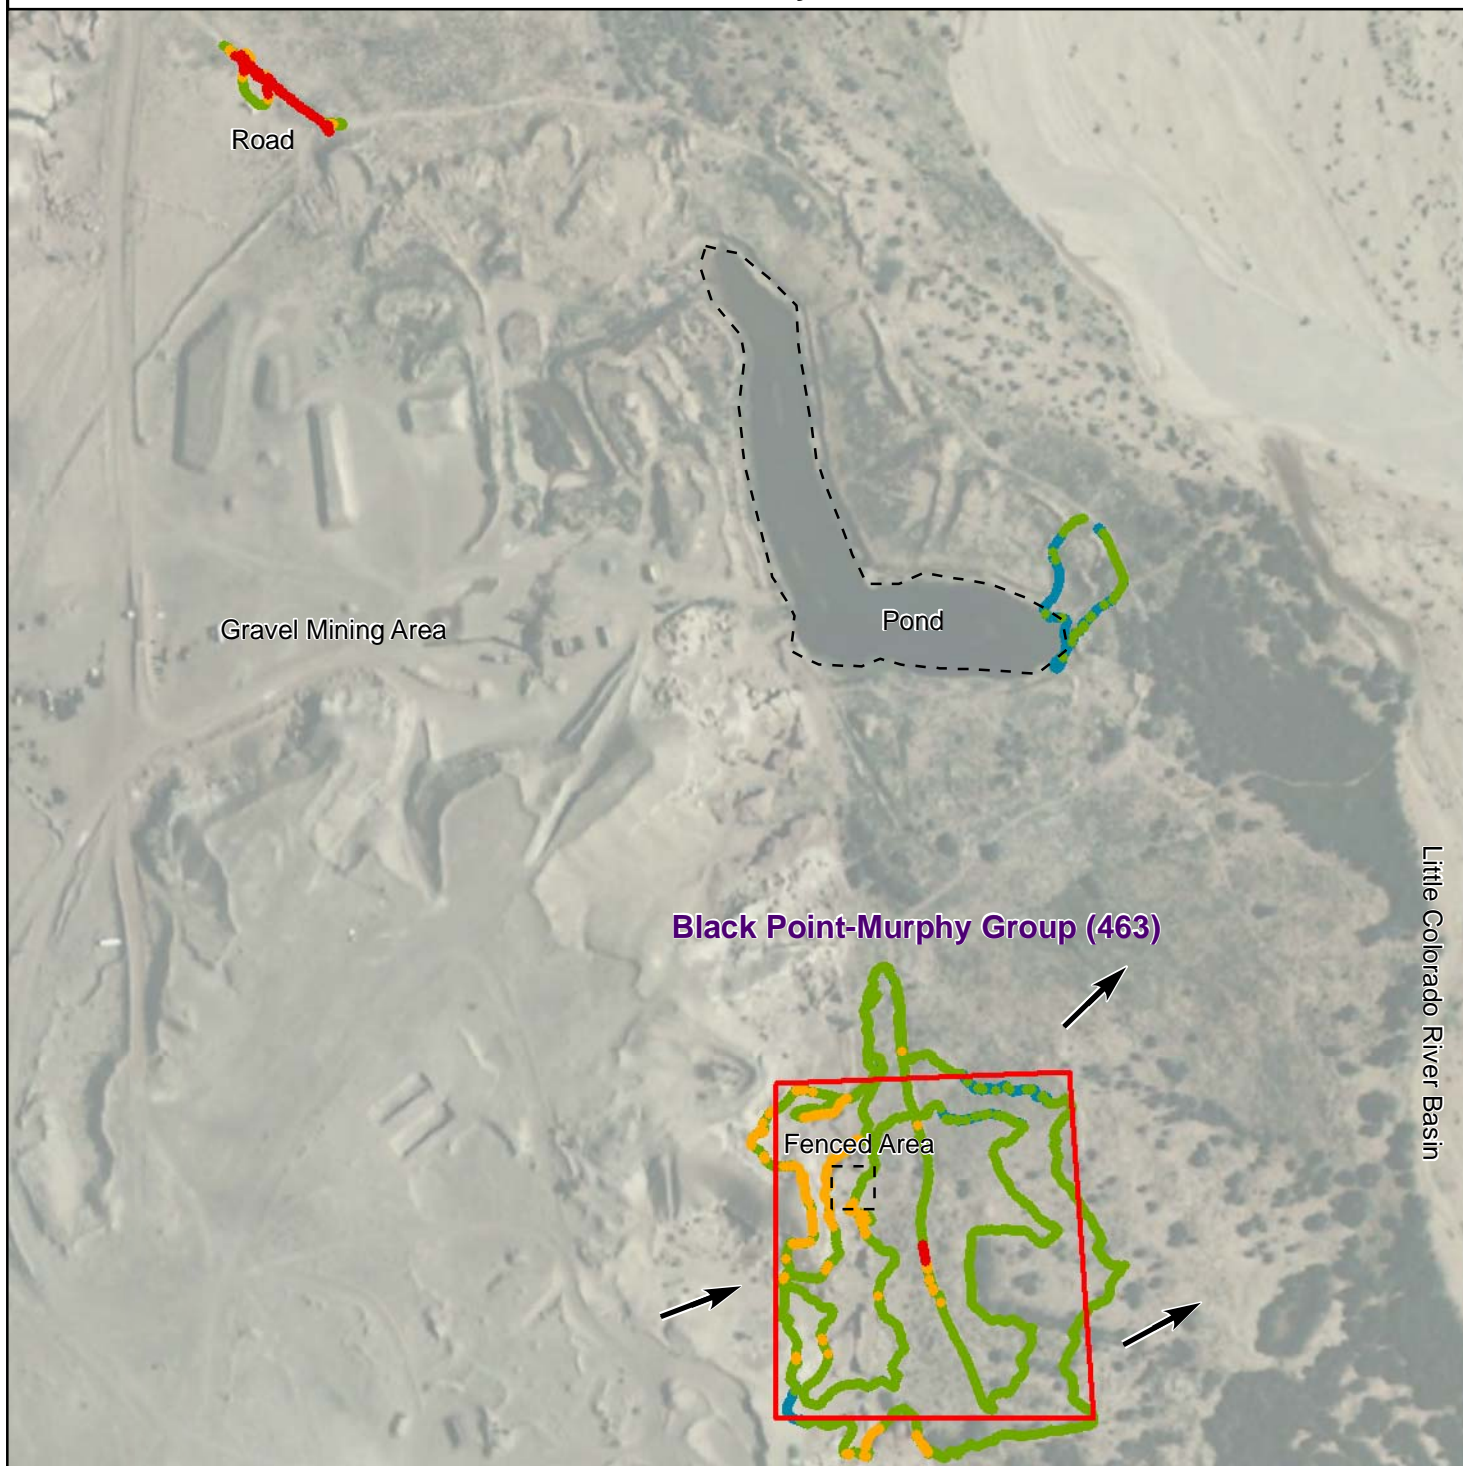
**Figure 2 - Gamma Radiation Measurements  
Black Point-Murphy Group (463)  
Coconino County, Arizona**

Gamma survey conducted 11/2010  
Measured as counts per minute (cpm)

Average background 11,605 cpm
